**DEPRECIATION REPORT AND
INSURANCE APPRAISAL
SPECIFIED PROPERTY OF:**

**Strata Plan VAS2893
767 North Road
Gibsons, BC**

**Depreciation Report with 3 Models – April 1, 2013 (Next Fiscal Year)
Replacement Cost New for Insurance Purposes – February 16, 2013**

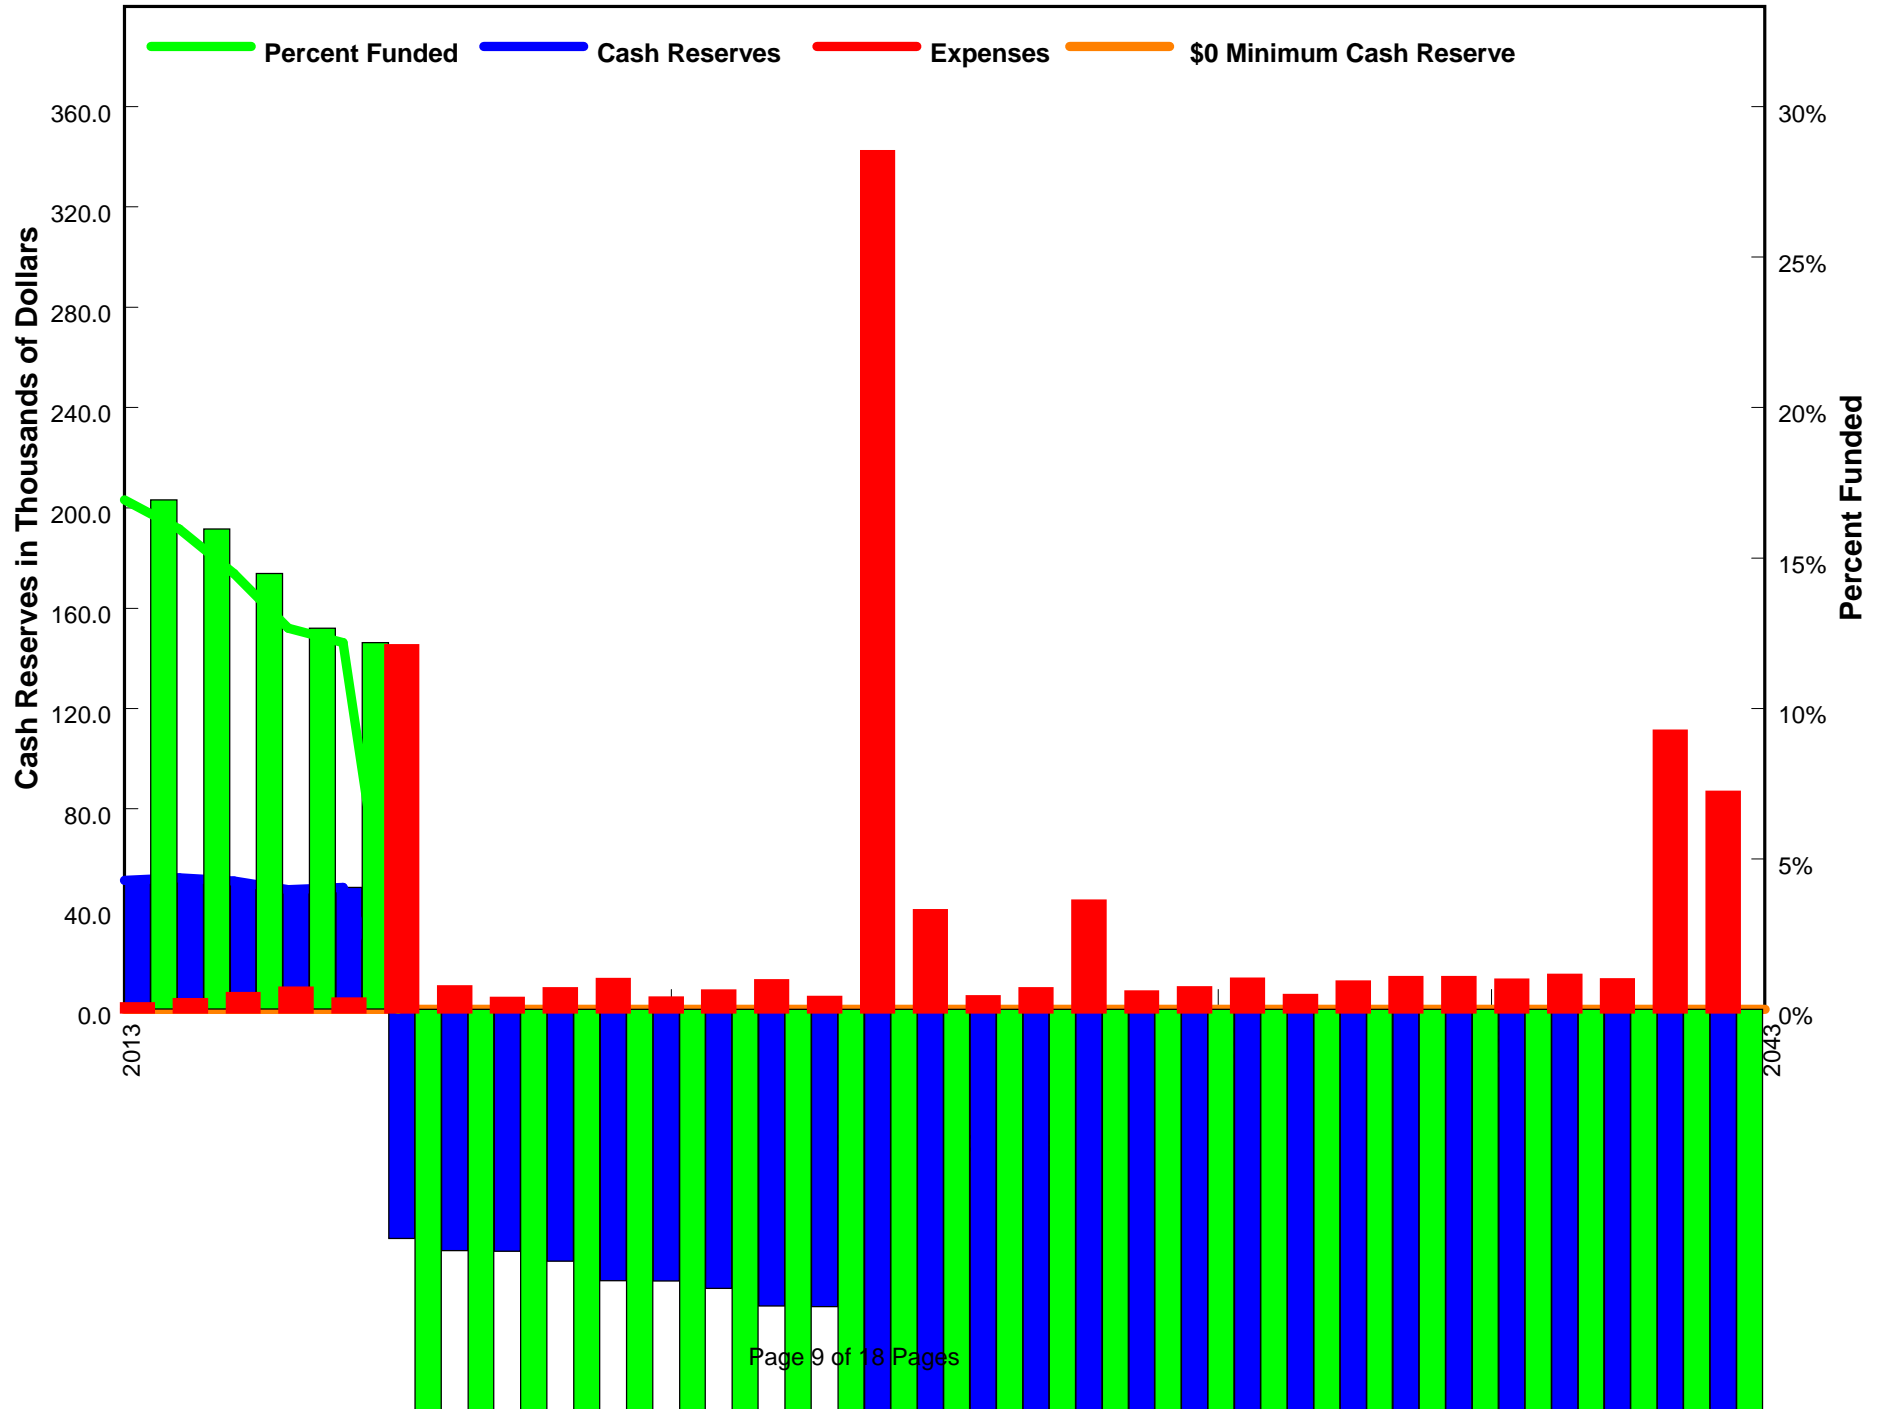
VAS2893 Model 1 Modified Reserve Dues Summary

Projected Dues by Month and by Fiscal Calendar Year

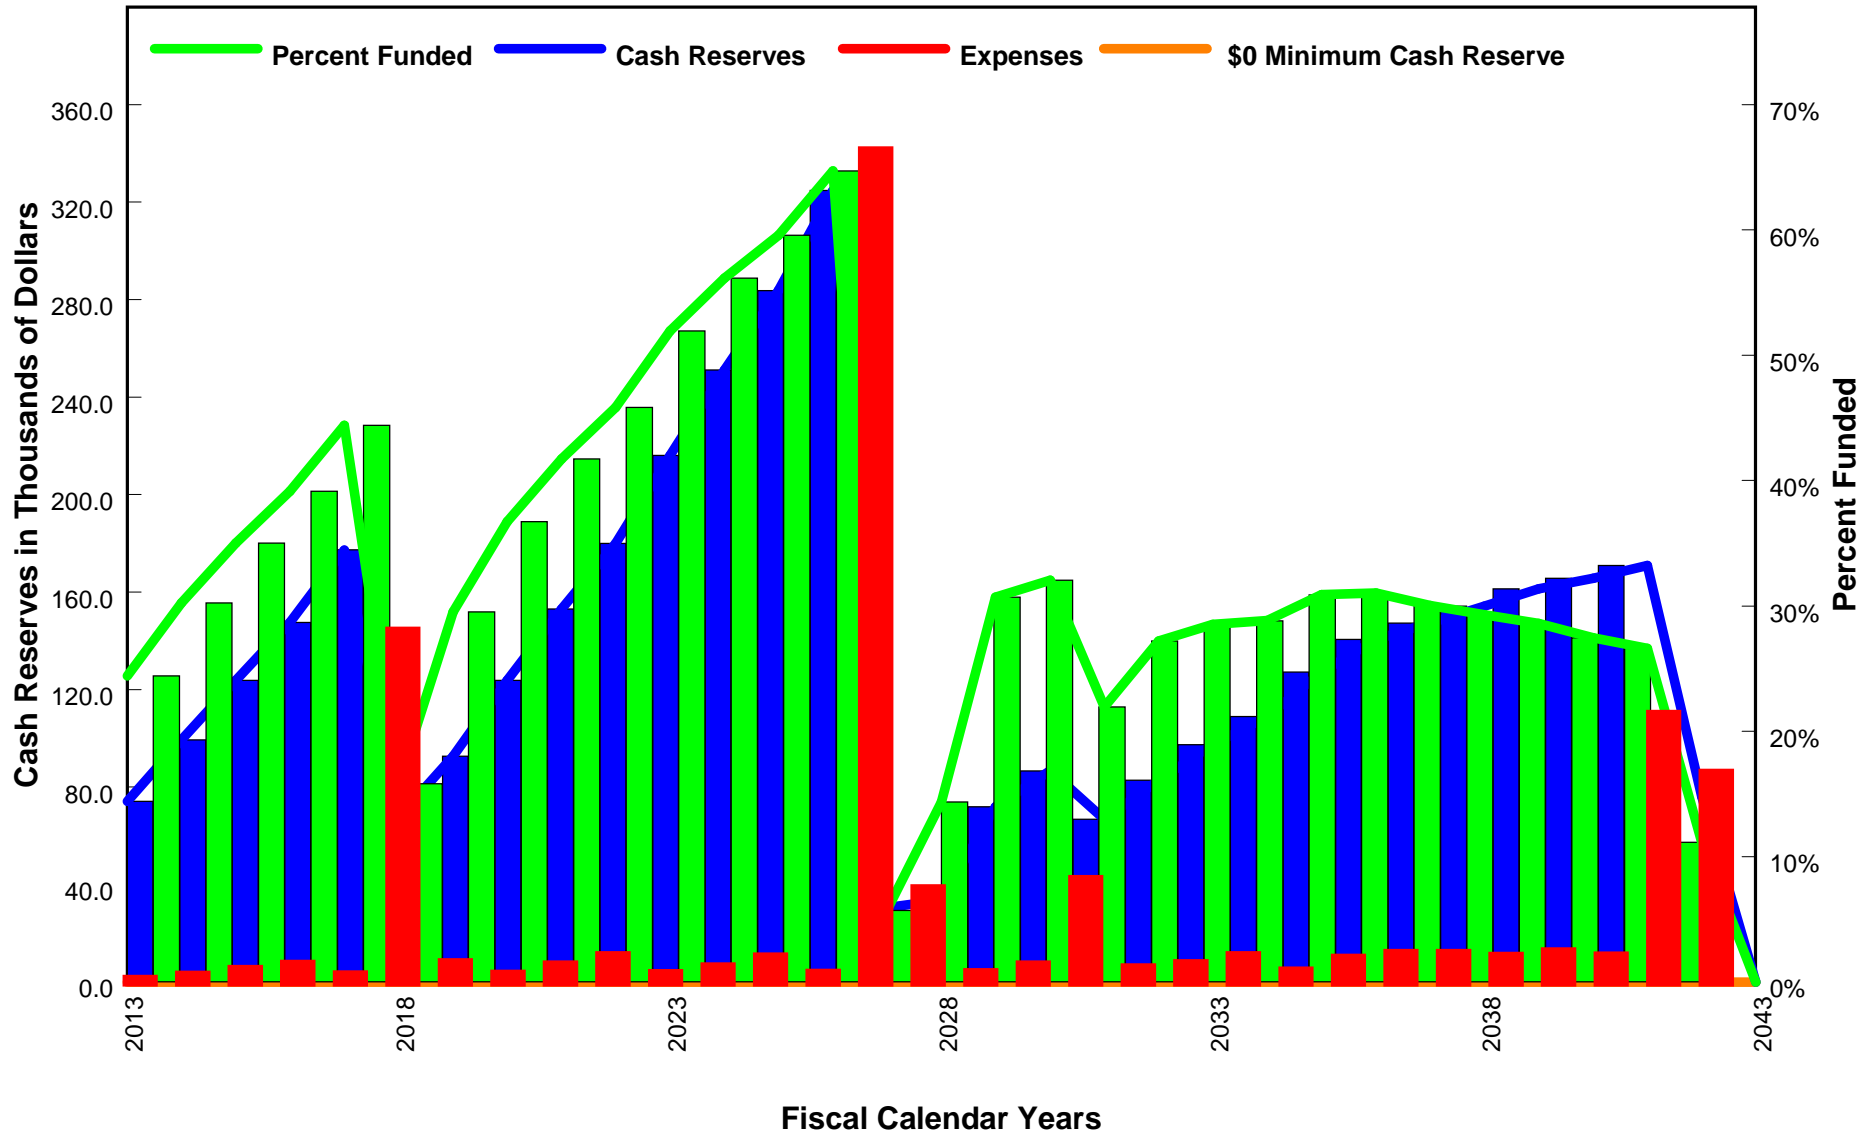
VAS2893 Model 2 Modified Reserve Dues Summary

Projected Dues by Month and by Fiscal Calendar Year

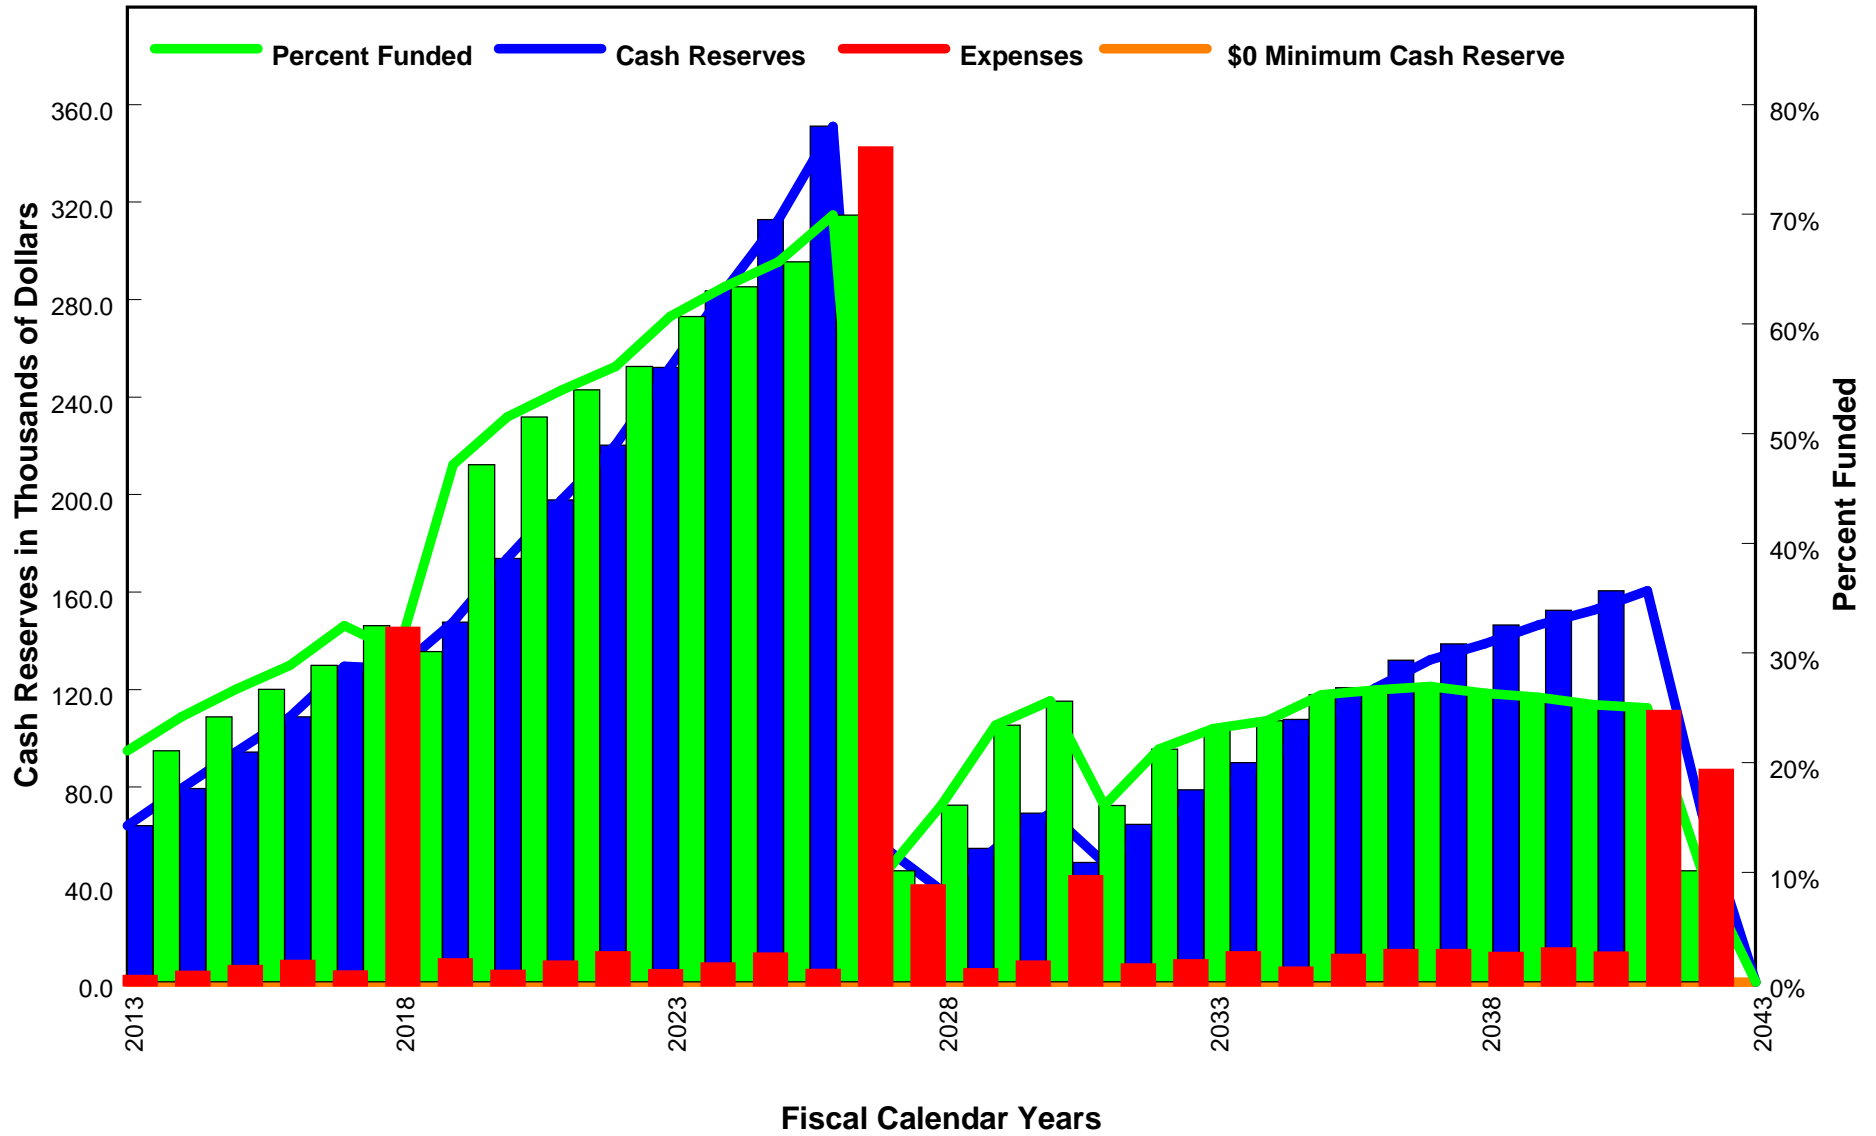
VAS2893 Model 3 Modified Reserve Dues Summary

Projected Dues by Month and by Fiscal Calendar Year
